**2023 ANNUAL LANDFILL INSPECTION REPORT
COAL COMBUSTION RESIDUALS FACILITY**

**EDEM REMEDIATION ONE, LLC
HOLLOW ROCK LANDFILL FACILITY
TORONTO, OHIO**

JANUARY 2024

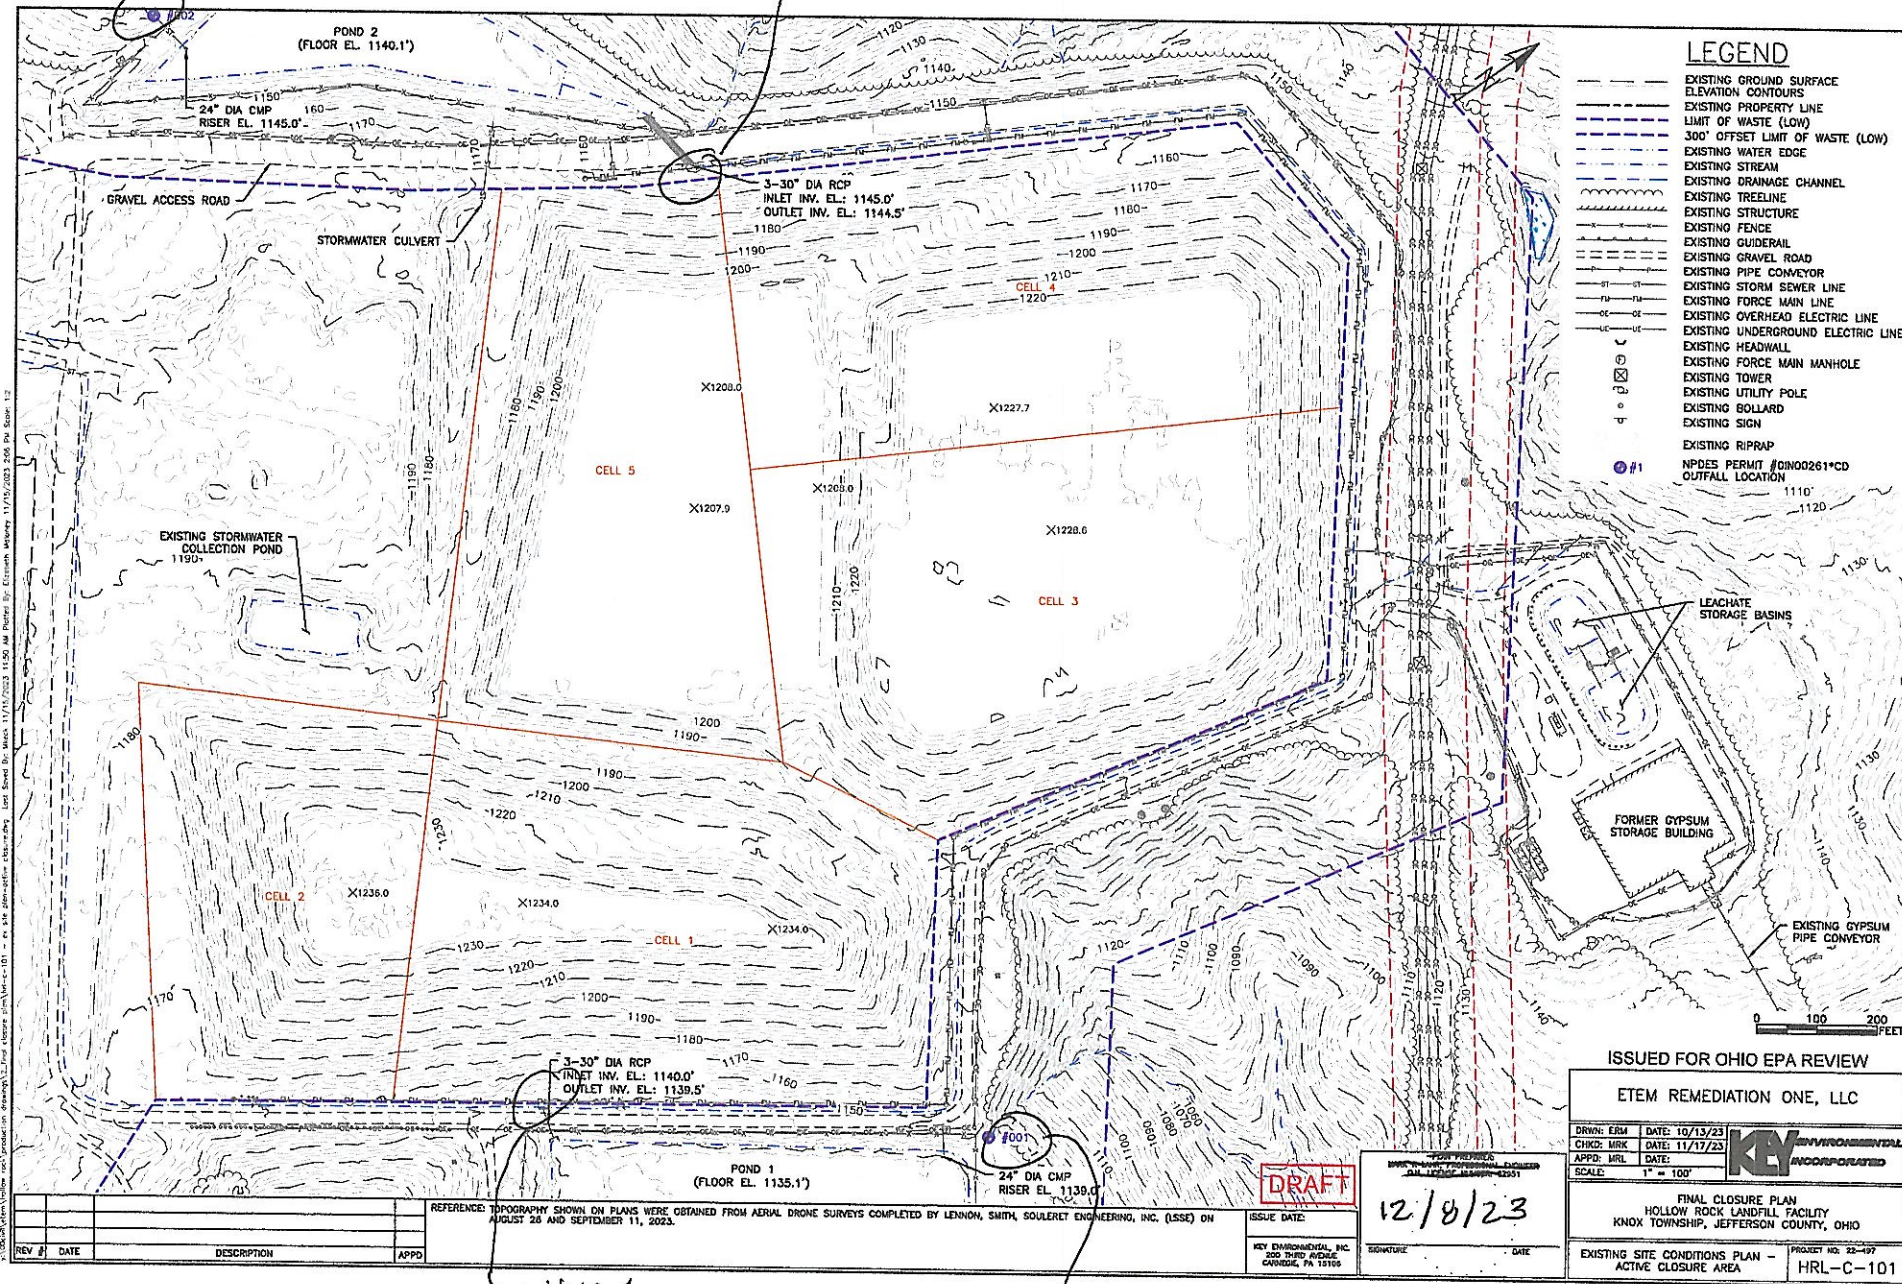
- 1- vegetation and sediment blocking landfill side of inlet pipes.
- 2- overgrown vegetation should be cleared.
- 3- discharge end of pipe is partially buried.

- Clear the landfill perimeter ditch of excessive vegetation (brush and small trees) and remove any sediment accumulated in the ditch outlet pipes for Stormwater Pond 1 and 2;
- For Stormwater Pond 1, the brushy vegetation at the emergency spillway should be cut; and,
- For Stormwater Pond 2, the discharge end of the outlet pipe should be cleared and the rock apron repaired.

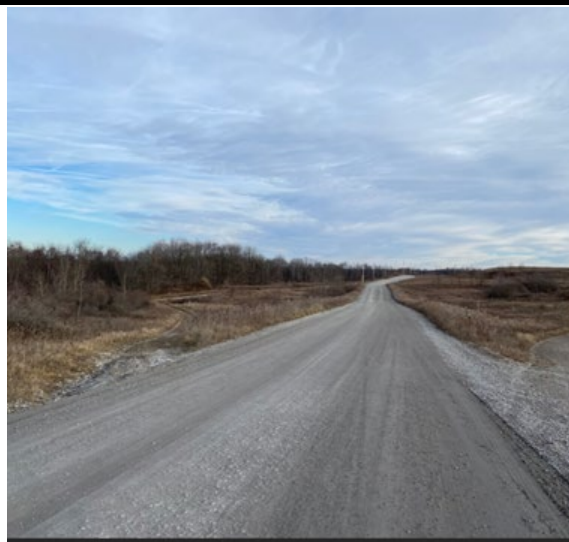
Photo: 1

Access Roads - some minor grading was completed.

Access Road Condition

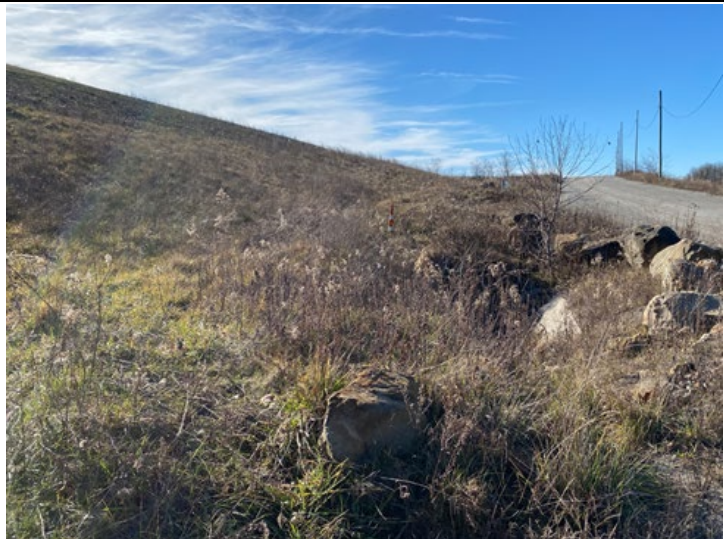
Photo: 11

West Side of Cell 5 at Outlet Pipes to Pond 2

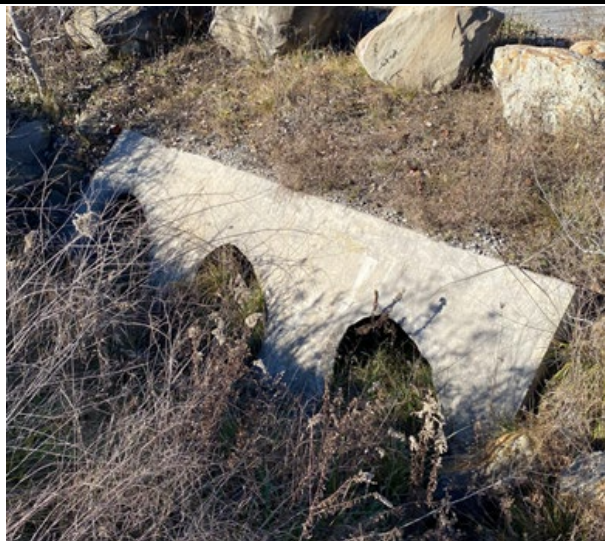
Photo: 12

Closeup of Channel Outlet Pipes to Pond 2

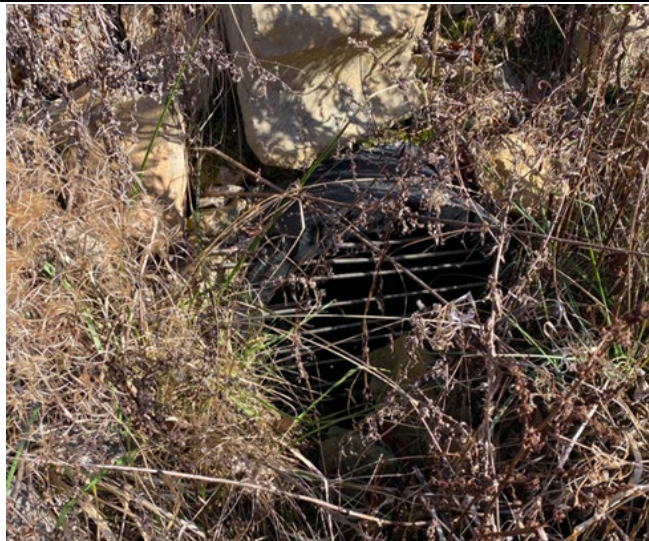
Photo: 14

Pond 2 Outlet Pipe Discharge End

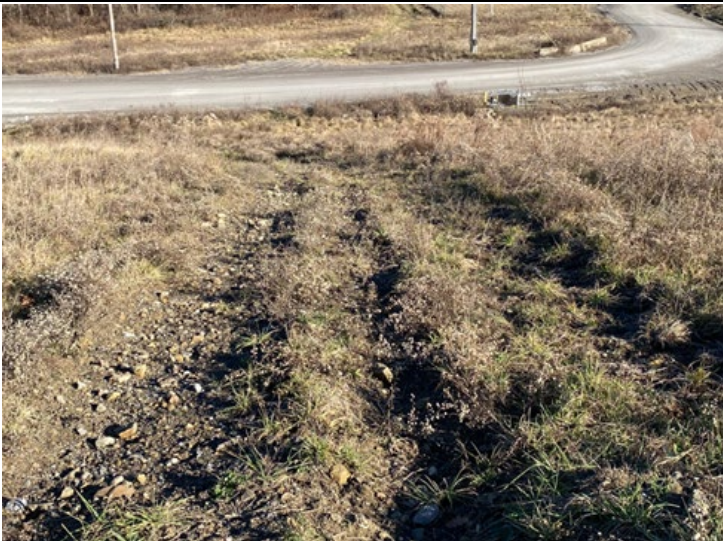
Photo: 20

Cell 4 North Face Some Surface Erosion (ATV)

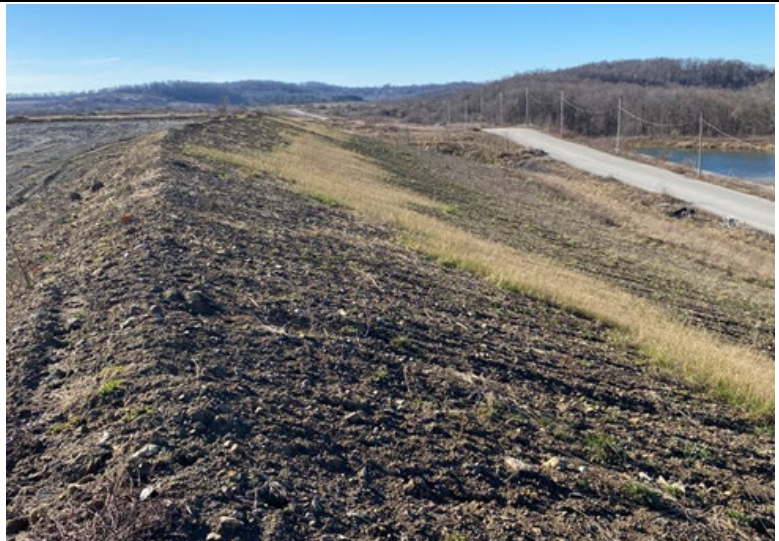
Photo: 23

Cell 5 Slope Cover Soil / Sparse Vegetation

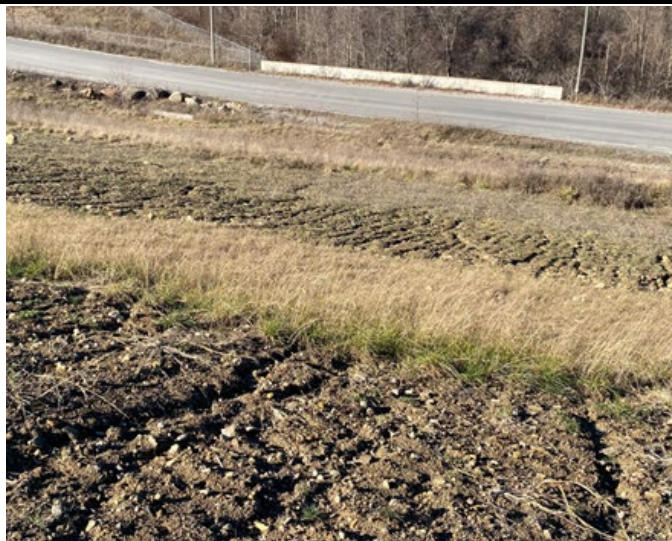
Photo: 24

Soil Erosion Rills on temporary cover placed on Cell 5 slopes

Cell 5 West Slope Some Erosion Rills

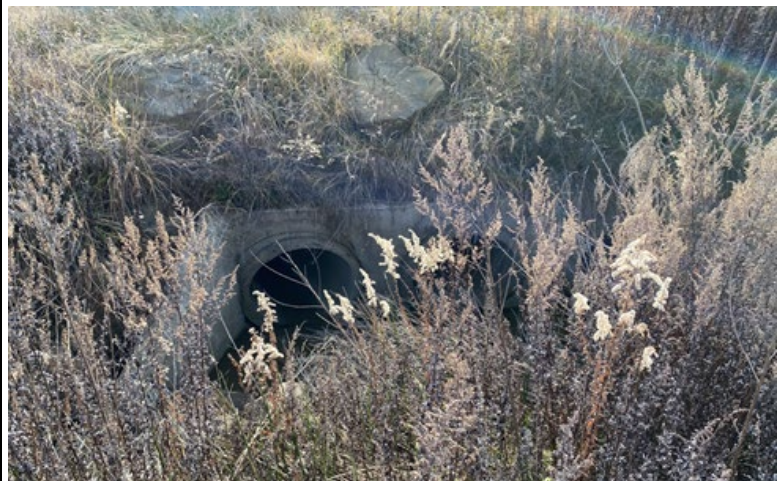
Photo: 30

Ditch Outlet Pipes to Pond 1

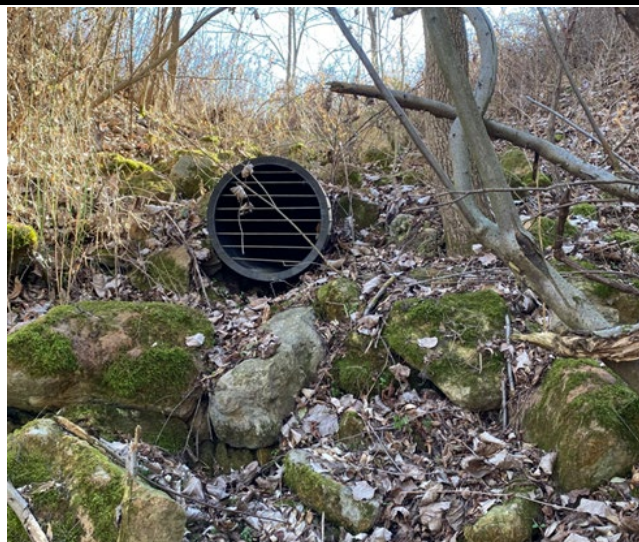
Photo: 32

Pond 1 Outlet Pipe Discharge End
