**2024 ANNUAL LANDFILL INSPECTION REPORT
COAL COMBUSTION RESIDUALS FACILITY**

**EDEM REMEDIATION ONE, LLC
HOLLOW ROCK LANDFILL FACILITY
KNOX TOWNSHIP, JEFFERSON COUNTY, OHIO**

DECEMBER 2024

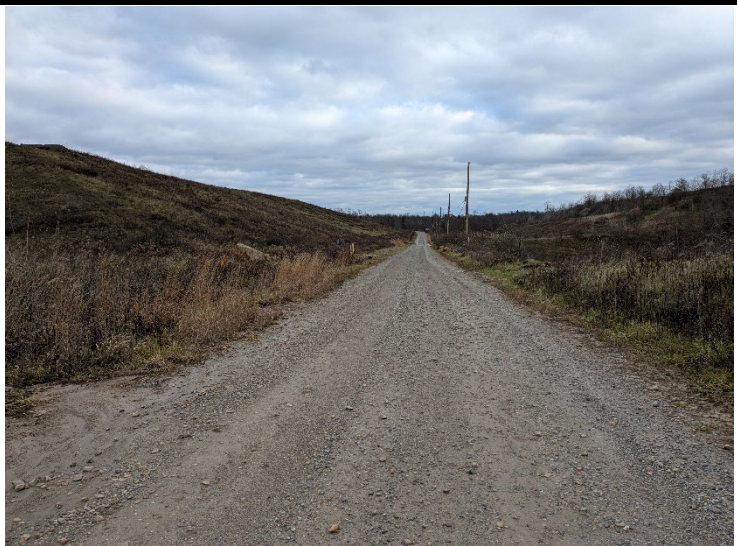
Access road southeast of Cell 2.
Photograph is looking northeast.

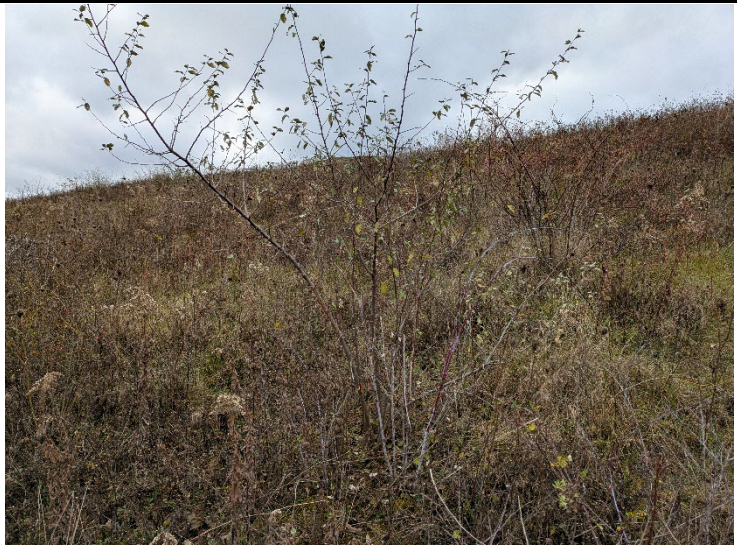
Photo: 5

Some woody vegetation was noted on the southeastern slopes of Cell 2 and Cell 1. Photograph is looking northwest.

- Continue to monitor the woody vegetation on the southeastern slope of Cells 1 and 2 and remove, as necessary;
- Repair the erosion on the haul road to Cell 5 and add additional stormwater diversion controls (i.e., rock check dams), as necessary;
- Continue to monitor the erosion rills including near the northwest Cell 4 access road and on Cell 5's temporary soil cover and repair, as necessary;
- Monitor and repair the leak observed at the Cell 4 sump riser and blind flange;
- Backfill, cover, or visually mark all open boreholes completed for the salvaging operations within the landfill's limit for safety purposes;
- For Pond 1, the brushy vegetation at the emergency spillway should be cut;
- Repair the cut chain-link fence near the outlet structure of Pond 2; and,
- For Pond 2, the discharge end of the outlet pipe should be cleared and the rock apron repaired.

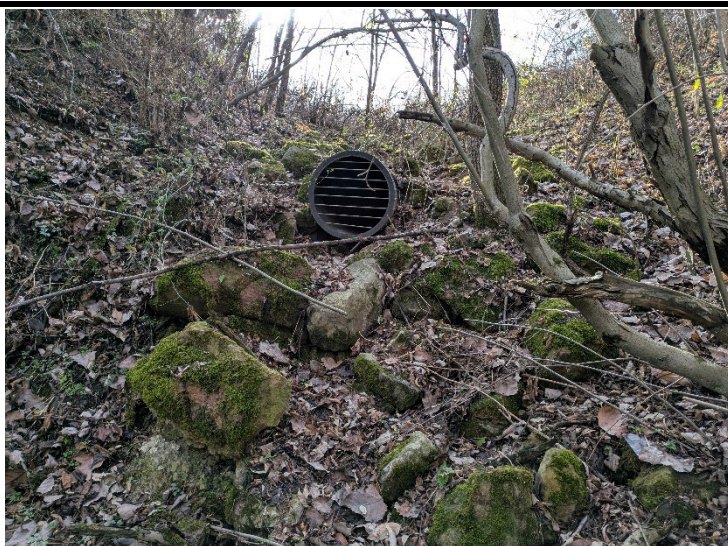
Photo: 12

Discharge location of the Pond 1 outlet pipe into the downstream channel. Photograph is looking southwest.

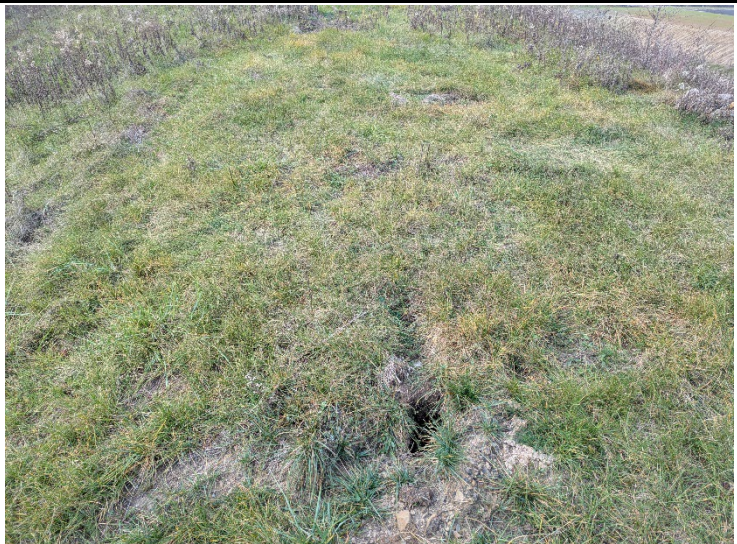
Photo: 15

View of an open bore hole on the top of Cell 1, assumed from the recent gypsum mining activities. All open boreholes should be backfilled, covered, or visually marked for safety purposes.

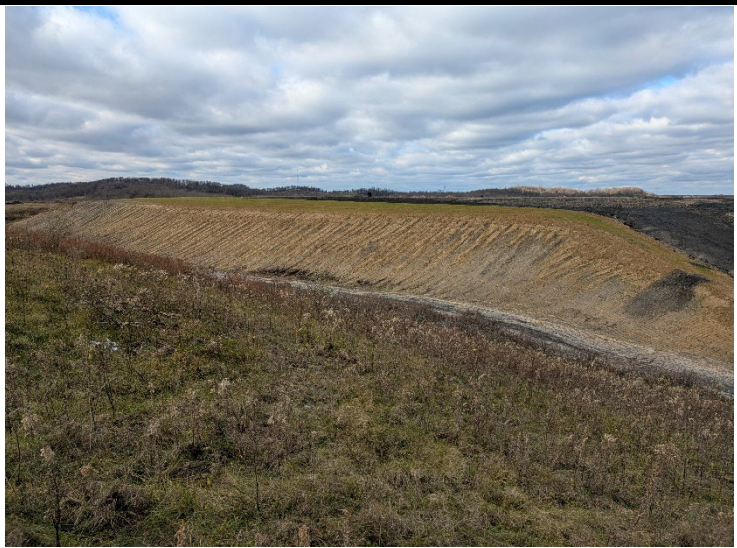
Photo: 19

View of southern slope of Cell 5, standing on the northern slope of Cell 1. Note the recent placement of temporary cover and seed. Photograph is looking northwest.

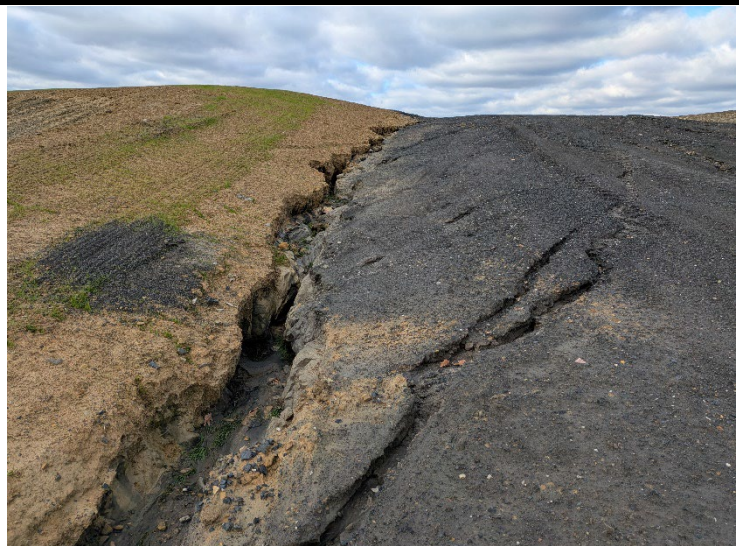
Photo: 22

Significant erosion noted between the access road and soil covered slope. Erosion should be repaired. Photograph is looking west.

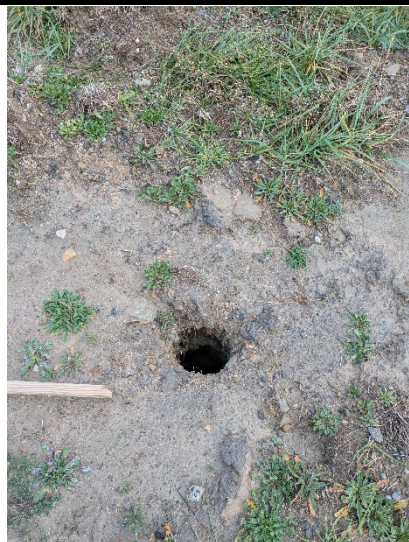
Photo: 31

View of an open bore hole on the top of Cell 4, assumed from the recent gypsum mining activities. All open boreholes should be backfilled, covered, or visually marked for safety purposes.

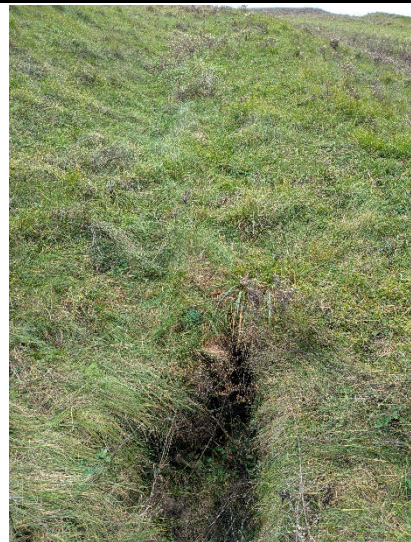
Photo: 39

Erosion noted near the access road on the northwest slope of Cell 4.

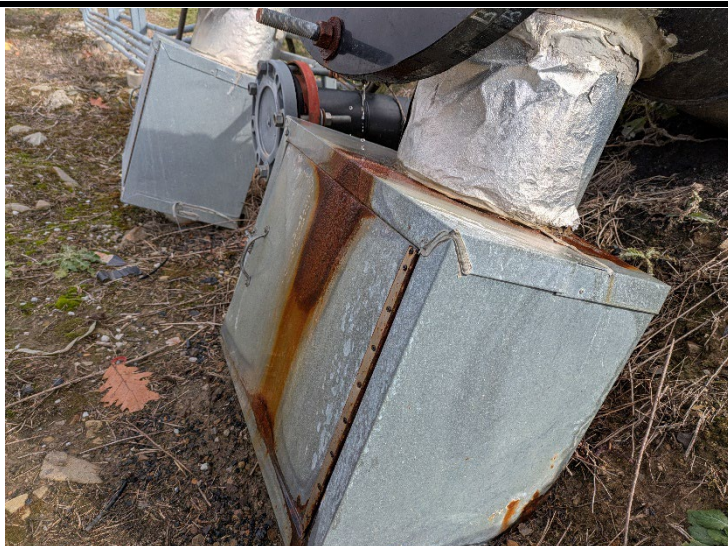
Photo: 43

Note 3 - Minor leaking observed at Cell 4 sump riser and blind flange
 Note 4 - Vegetation/debris cleared from culvert entrances noted from 2023 inspection
 Note 5 - overgrown vegetation should be cleared
 Note 6 - Discharge end of pipe remains buried

Water observed leaking from the blind flange at the Cell 4 sump riser.

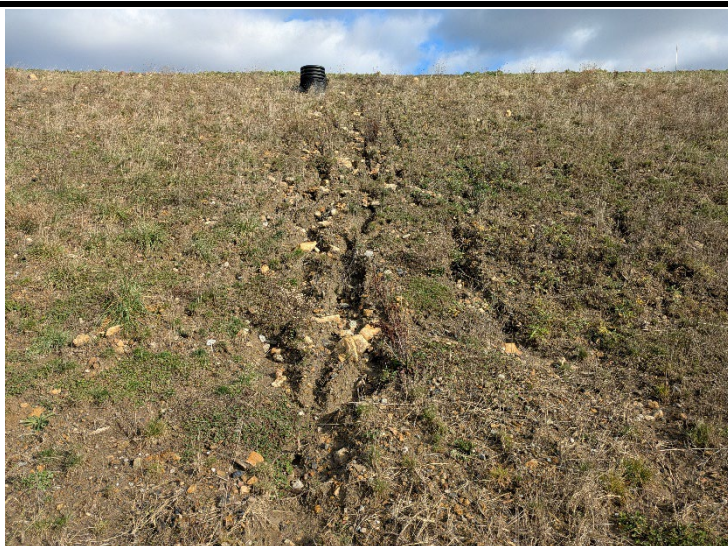
Photo: 45

Soil Erosion Rills - Noted on Cell 5 temporary soil cover

Southwest slope of Cell 5. Erosion rills were observed on much of the slope face. Photograph is looking northeast.

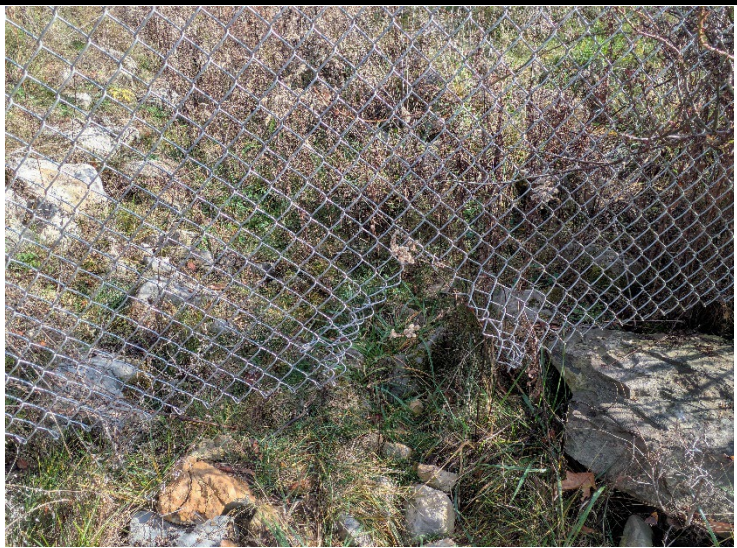
Photo: 52

Chain link fence surrounding Pond 2 was cut, potentially providing site access to trespassers.
